Alloy Wheel Non- Repairable Core Visual

What Makes a Core Non-Repairable?

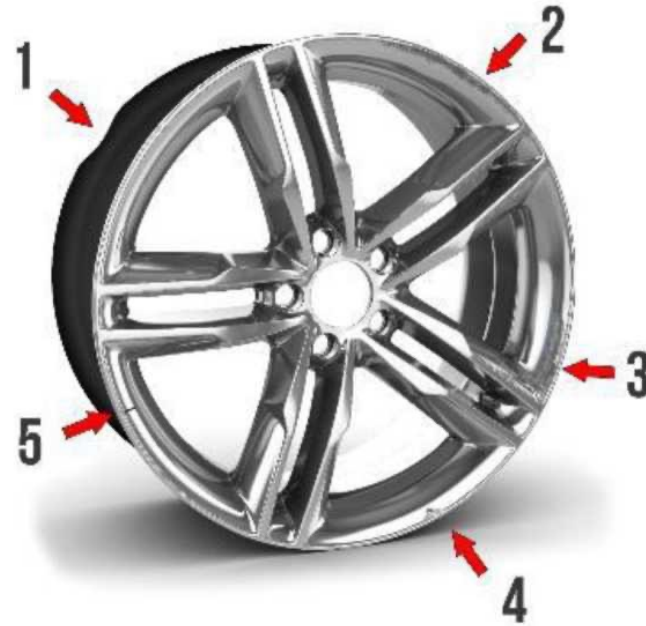
Alloy Wheel Damage Types

1 - Backside/Frontside Bends

PROBLEM: Occurs frequently on the inner lip of the wheel but possible on the outer lip, spokes, or face. Bends are usually a result of a pothole, curb, or other road hazard.

SOLUTION: Bends are inspected for hidden fractures and run out is measured to determine if safe to straighten. Bends are returned to balanceable trueness with patented straightening system.

2 - Curb Damage

PROBLEM: Typically the result of curb rash, road debris, or driving on a flat tire. Damage is generally located on the lip of the wheel, spokes, or face.

3 - Corrosion

PROBLEM: Caused by roadside chemicals, salts, brake dust, tire sealants, or other external elements.

4 - Gouges/Missing Metal

PROBLEM: Often the result of direct contact with road debris and/or hazards.

5 - Minor Cracks

PROBLEM: Can occur because of car accident or hard impact with road debris and/or hazard.

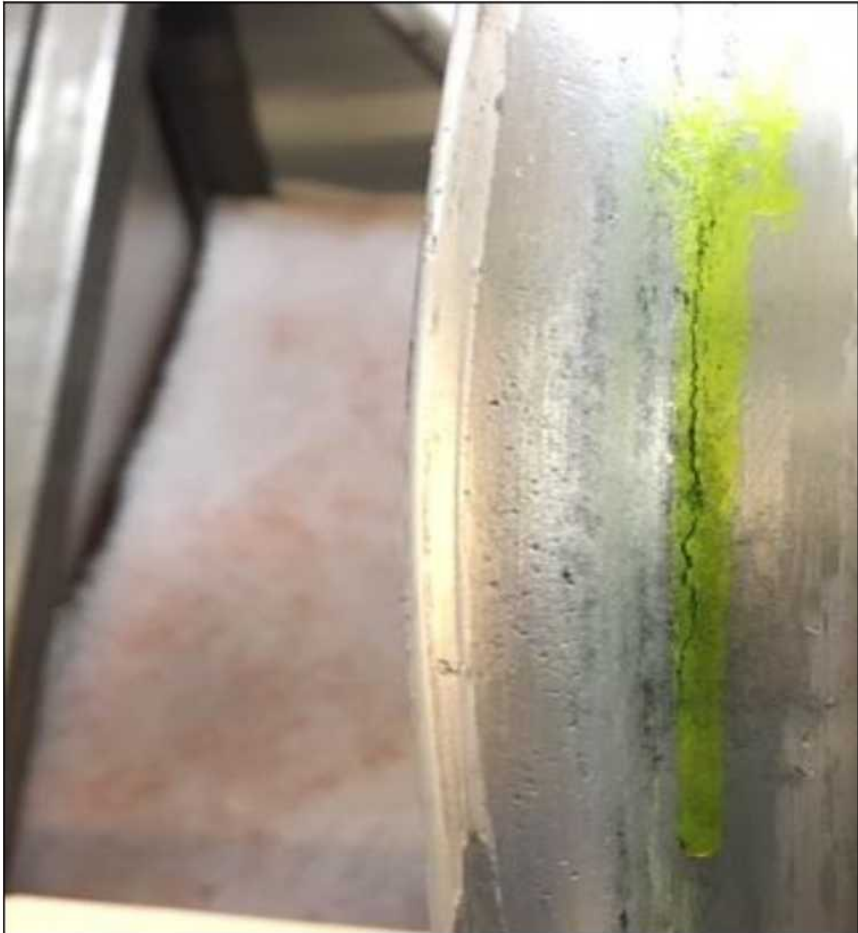
Cracked Wheel Examples

Example of a crack that extends through the bead seat area, past the safety hump.

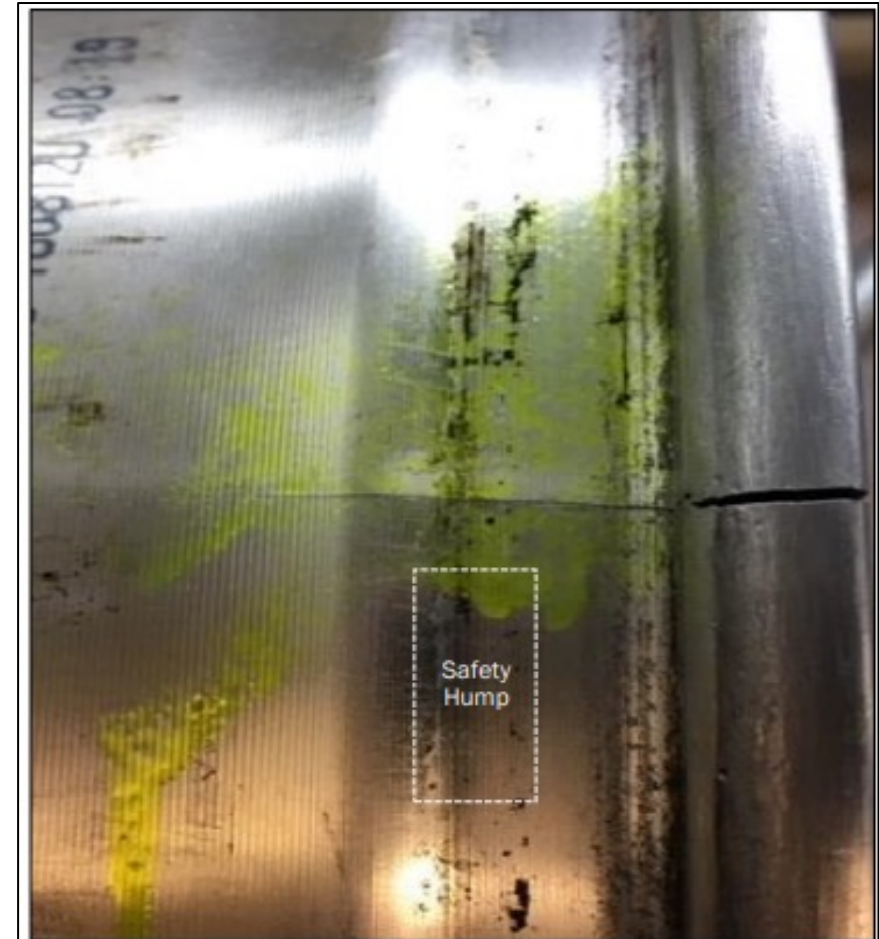
Example of a crack that extends from the flange through the bead seat area, past the safety hump.

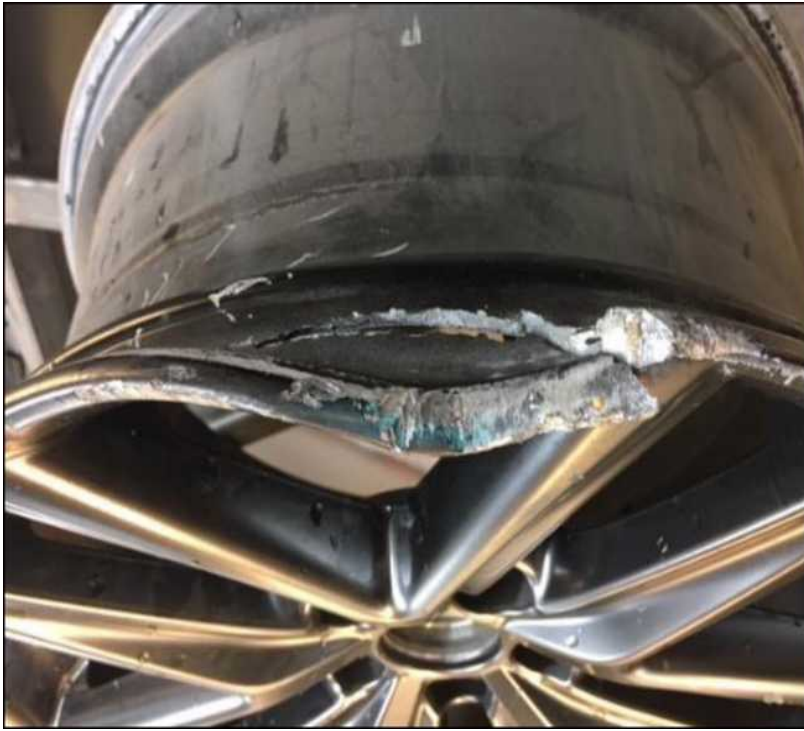
Severe Damage Visuals

Example of severe structural damage to the face of the wheel.

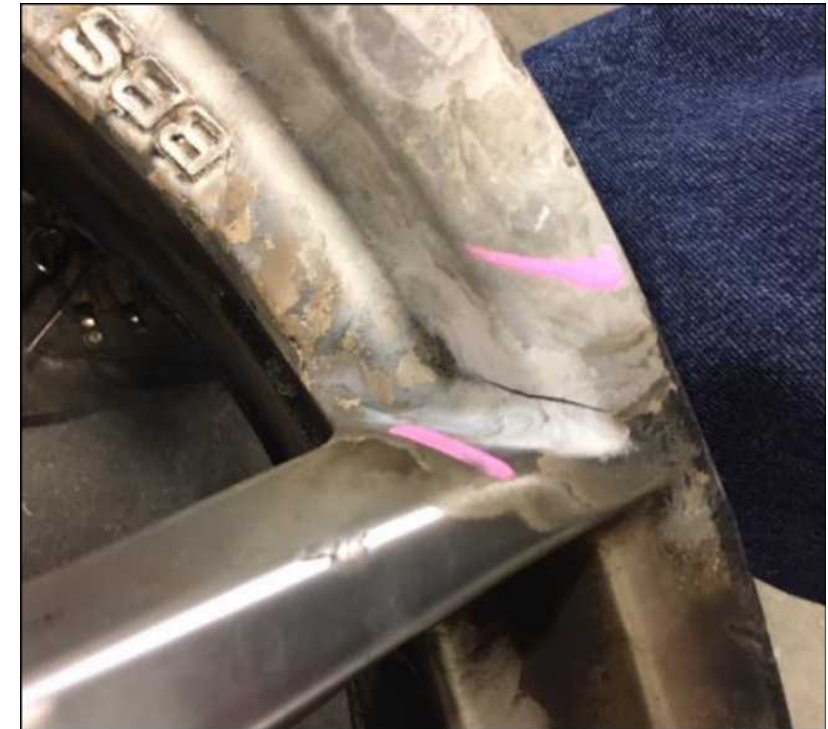
Example of a crack in the spoke on the face of the wheel.

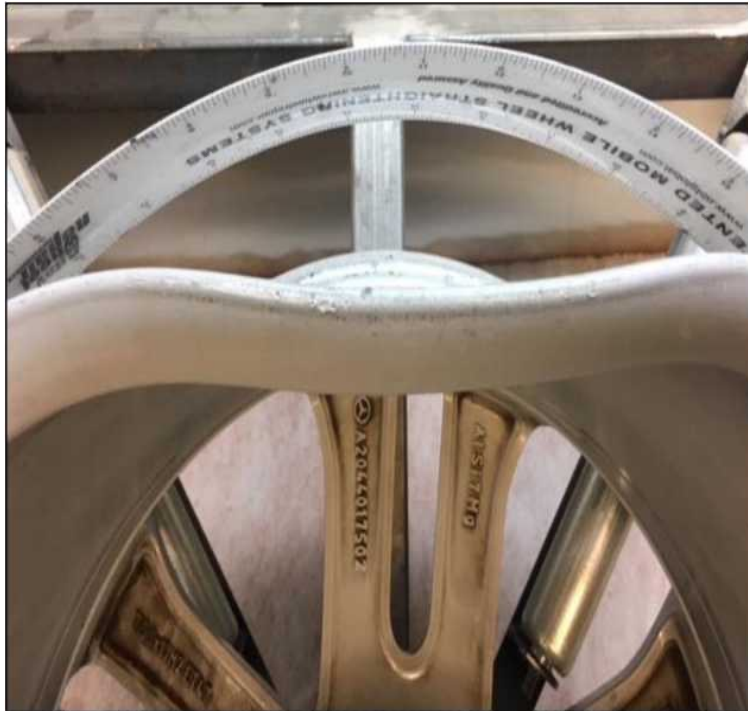
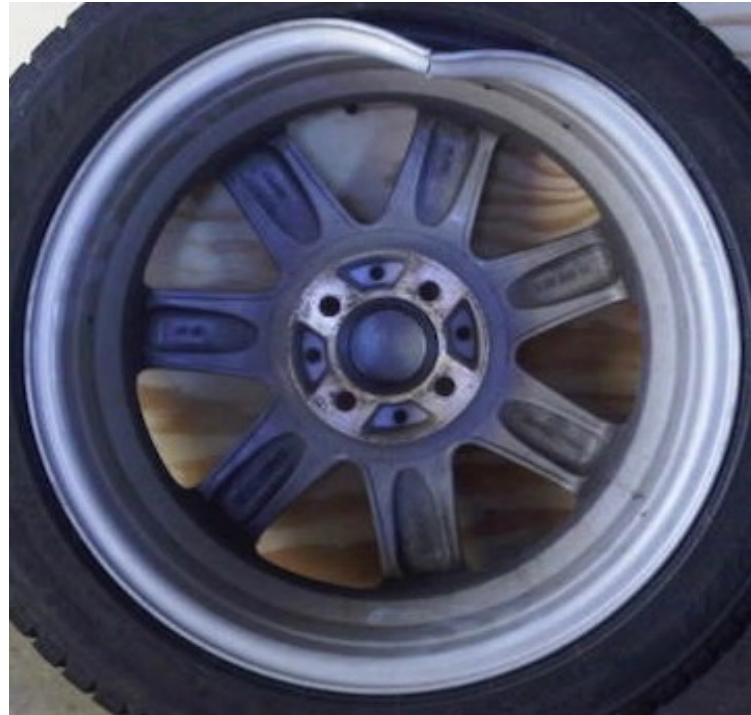
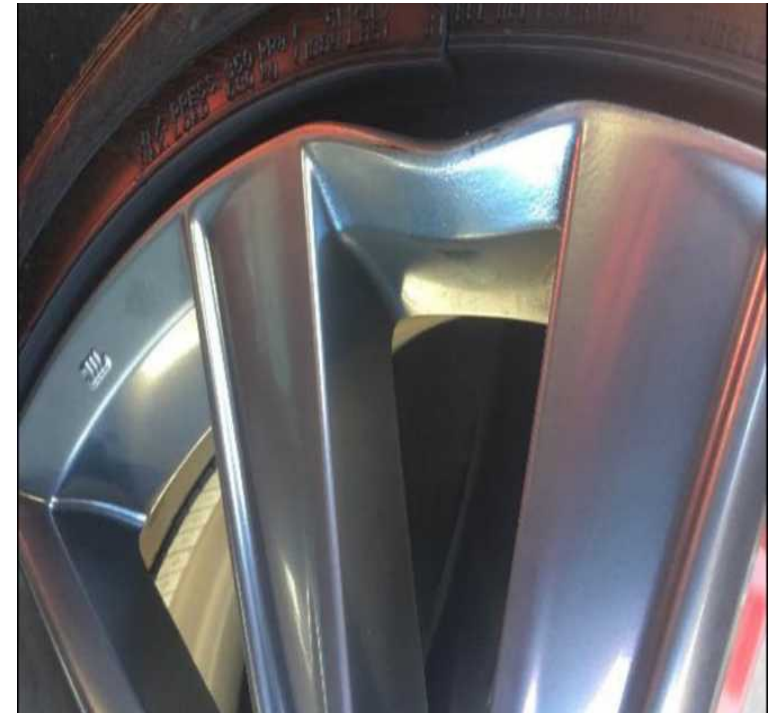
Non-Repairable Bends

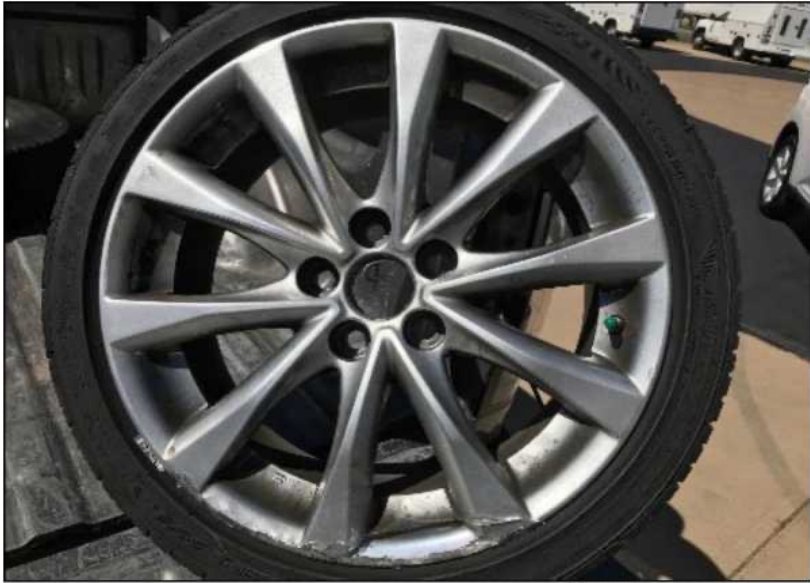
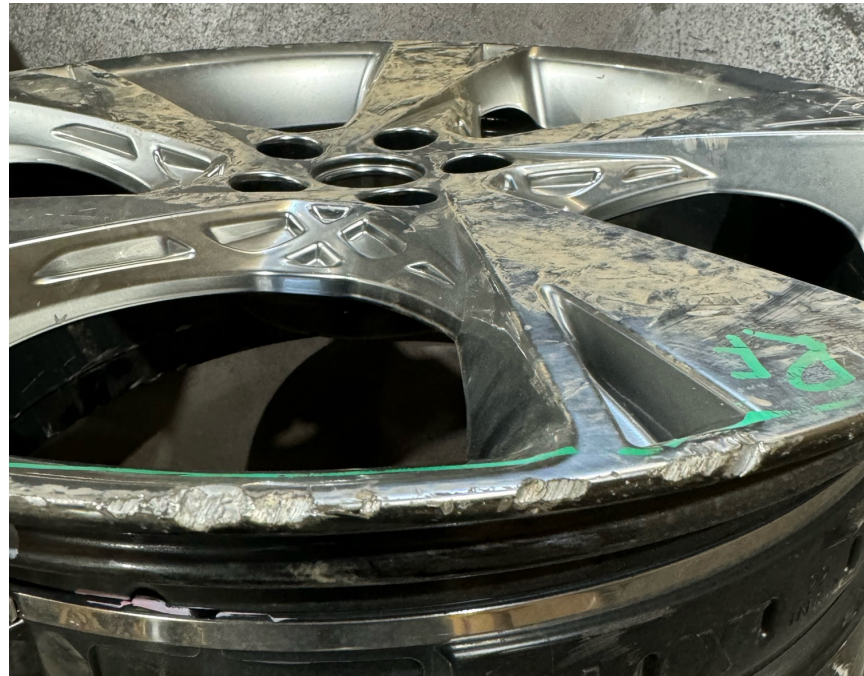
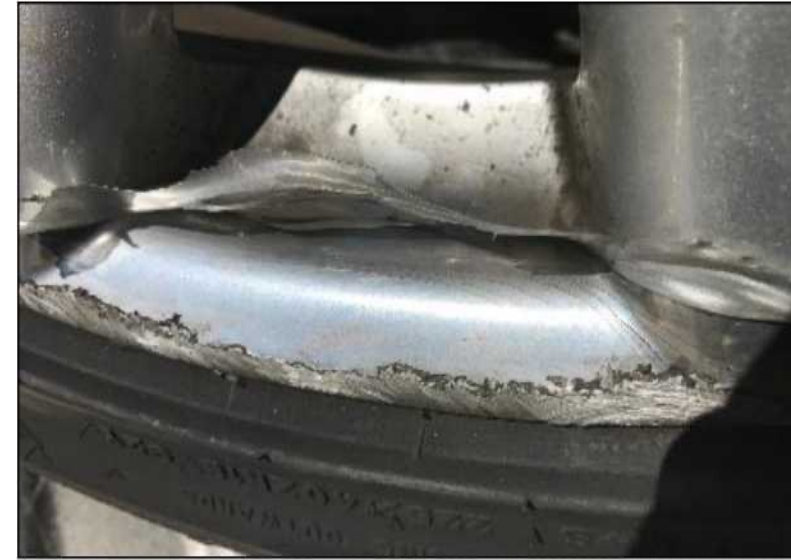
Severe Scars on Wheel Face
